**IR Heating System for drying of Touch-up Paint
on Weld seam and Top Chime**

Customer :	M/s. Metal Seam Co. Pvt. Ltd.
Process :	IR Heating System for treatment of Touch-up Paint on Drum Weld Seam and Top Chime

Test Report No: 220/KRDC/LAB/17 Mum 15/05/2023

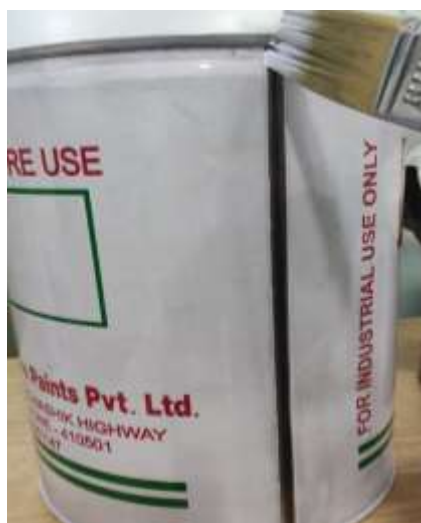
Touch-up Paint on weld seam

Initial Component

Trial 5 – Touch-up Paint on weld seam

Sr. No.	Cycle Time	Specifications of System	On Product temperature	Remark
1	After 30 sec	Set Temp: 100°C; IR Intensity: 80%	(56-60)°C	Drying started
2	After 60 sec	Set Temp: 100°C; IR Intensity: 80%	(60-67)°C	Drying Continuous
3	After 90 sec	Set Temp: 100°C; IR Intensity: 80%	(67-70)°C	Drying Continuous
4	After 120 sec	Set Temp: 100°C; IR Intensity: 80%	(70-73)°C	Dried as Desired

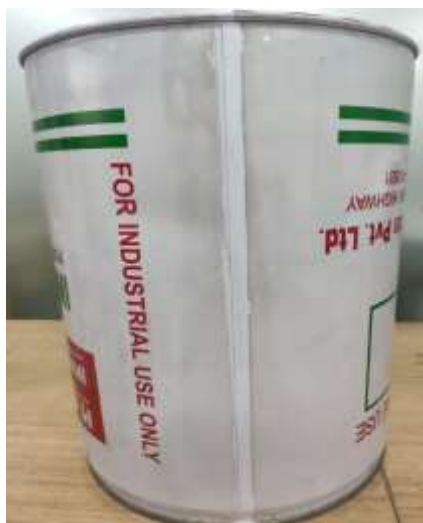
Touch-up Paint Applied weld seam

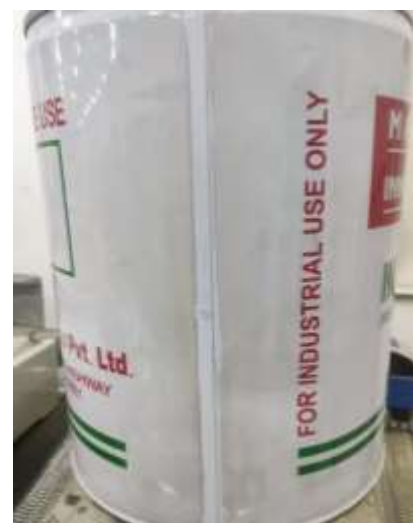
After drying Component

Total Cycle time – 2 mins.

On product temperature – (70-73) °C

The heating behavior of the Touch-up paint was investigated under the IR heating system. The heating rate was found to be increasing with respect to the increase in time. As per the physical investigation, it was observed that the product was dried as desired. The touch paint on the weld seam and top chime surface drying were done within a short period of time.

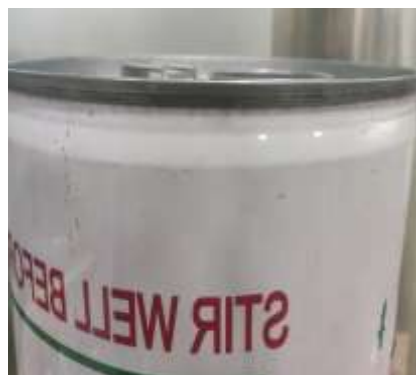
Touch-up Paint on top Chime

Initial Component

Trial 6 – Touch-up Paint on top Chime

Sr. No.	Cycle Time	Specifications of System	On Product temperature	Remark
1	After 30 sec	Set Temp: 100°C; IR Intensity: 80%	(55-60)°C	Drying started
2	After 60 sec	Set Temp: 100°C; IR Intensity: 80%	(64-68)°C	Drying Continuous
3	After 90 sec	Set Temp: 100°C; IR Intensity: 80%	(68-70)°C	Drying Continuous
4	After 120 sec	Set Temp: 100°C; IR Intensity: 80%	(70-71)°C	Dried as Desired

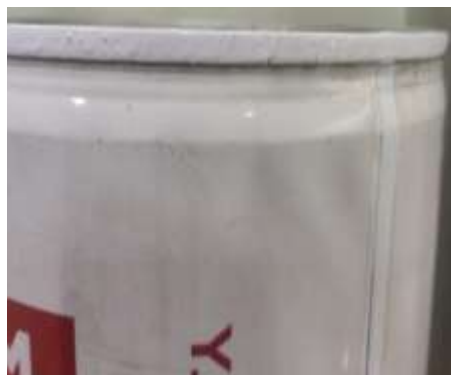
Touch-up Paint Applied Top Chime

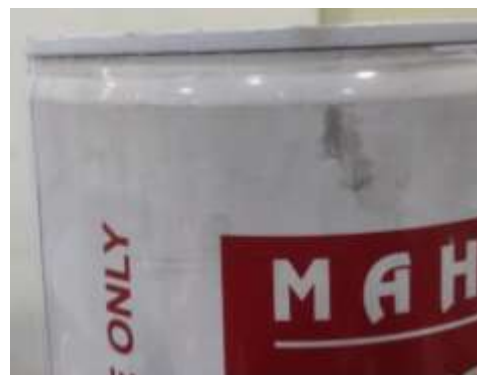
After drying Component

Total Cycle time – 2 mins.

On product temperature – (70-71) °C
