Kerone Research & Development Centre (KRDC)

<b>Customer:</b>	
Process:	Heat Pump Dryer for Drying of Marigold Flowers

#### Test Report No: 243/KRDC/LAB/17 Mum 02/11/2023

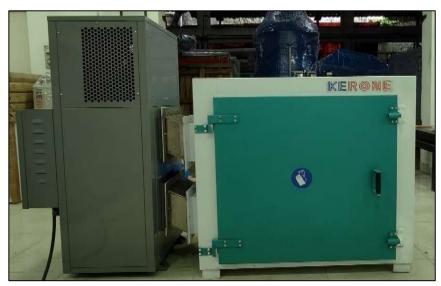
## Laboratory Experimental System -

#### **System Specifications** –

IR Power	5 kW		
Type of IR Emitters	Quartz Infrared		
Rotary Drum Size	Φ324 mm x 800 mm long x 3mm Thick.		
Thermal Monitoring System	Single Channel Fiber Optic: Range -40 to 250°C		
Exhaust	Exhaust port with manual damper		
Air Circulation Fan	Radial Fan FHP 0.5HP

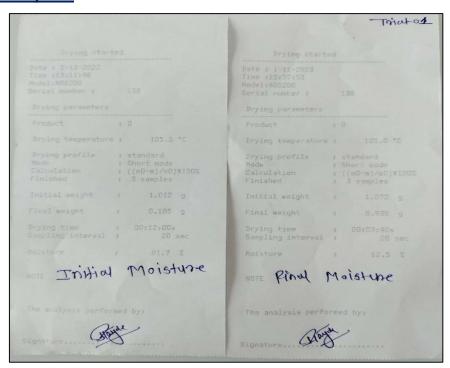
# Moisture Analysis Report:

**Initial Moisture: 81.7%**

**Final Moisture: 12.5%**

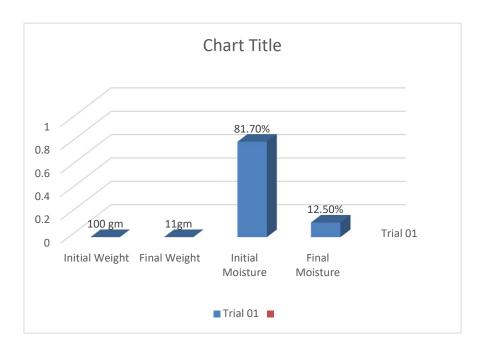
#### **Histogram:**

The heating behavior of Marigold Flowers was investigated under the Heat Pump Dryer system. The heating rate was found to be increasing with respect to increasing in time. The physical investigation observed that the product was dry without any Cheering effect.
